SITKA
Fine Arts Camp

**Sheldon Jackson
School National
Historic Landmark
Allen Hall Walkways**

Rehabilitation

Walkways
Concept

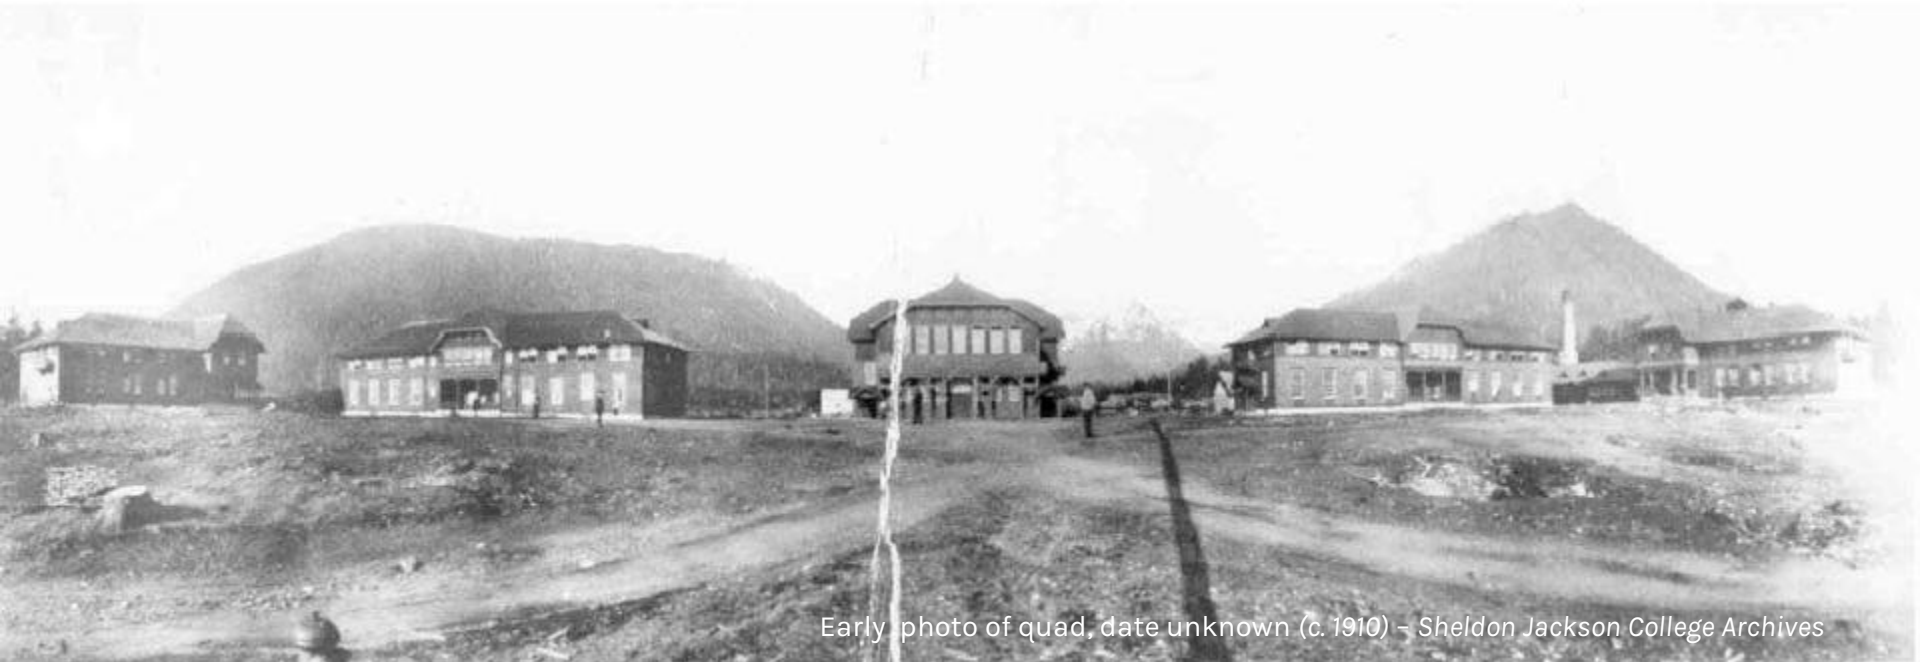
Early photo of quad, date unknown (c. 1910) – Sheldon Jackson College Archives

Ludlow and Peabody Plan 1910-1911

- ▶ Only formal campus plan in Alaska
- ▶ Craftsman and Western stick architectural elements
- ▶ Overlooks Sitka Sound (now Crescent Harbor)
- ▶ Buildings arranged around a central quadrangle

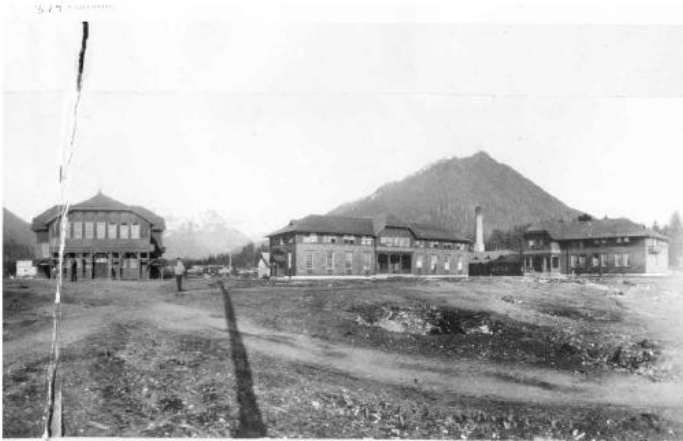
Early photo of quad, date unknown (c. 1910) –
Sheldon Jackson College Archives

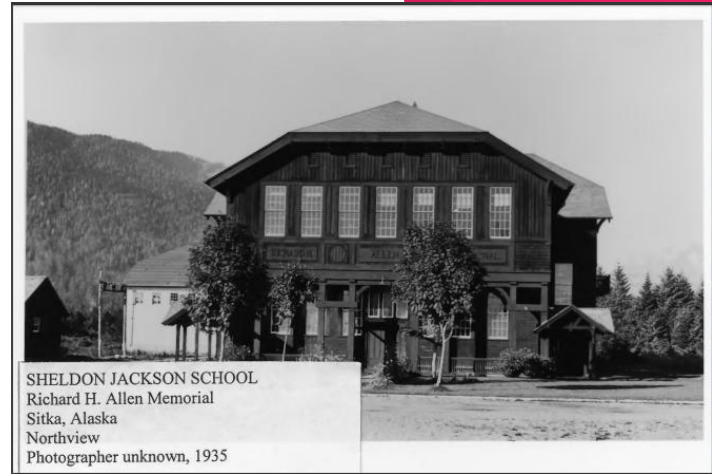
SHELDON JACKSON SCHOOL
Richard H. Allen Memorial
Sitka, Alaska
Northview
Photographer unknown, 1935

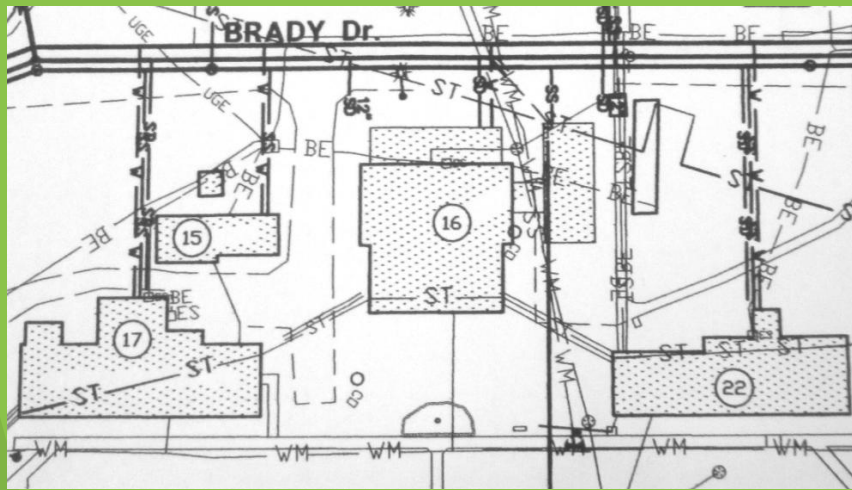
Various plans- 2000, 2003

2000 Campus Utilities
(New Water, Stormdrain and Sewer as well as existing buried steamline, buried electric, underground electric)

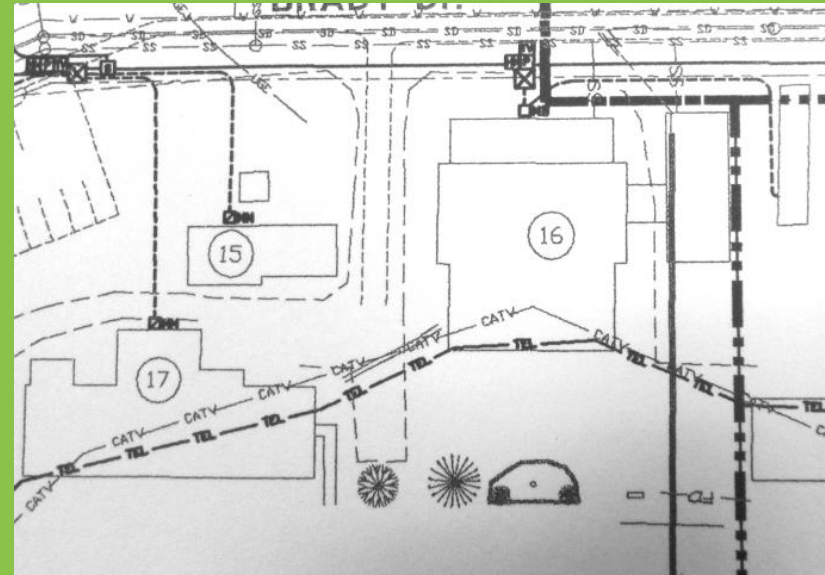
2003 Campus Utilities
(Electric and communications)

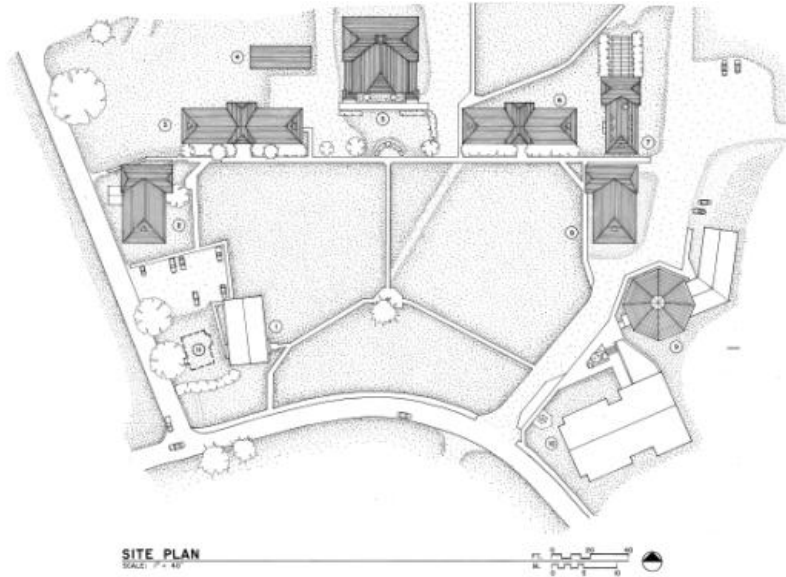
- A grade that slopes to the south
- An unobstructed view of Sitka Sound
- Axial symmetry with a focus on Allen Hall
- A forecourt south of Allen Hall

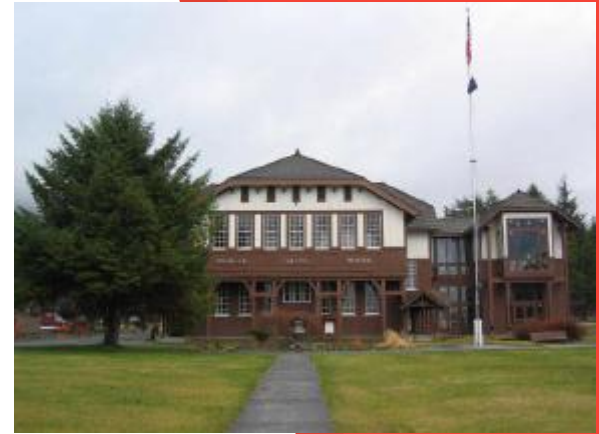
- Re-establish the forecourt in front of Allen Hall as the focal point of access (remove bell and surrounding vegetation)
- Main approach to the campus from the south (through historic concrete entrance gates)
- Open spaces between the buildings should remain open (landscape with grass)
- Only shrubs should be planted around the buildings and should be placed in such a manner that they reinforce entry points to the buildings.

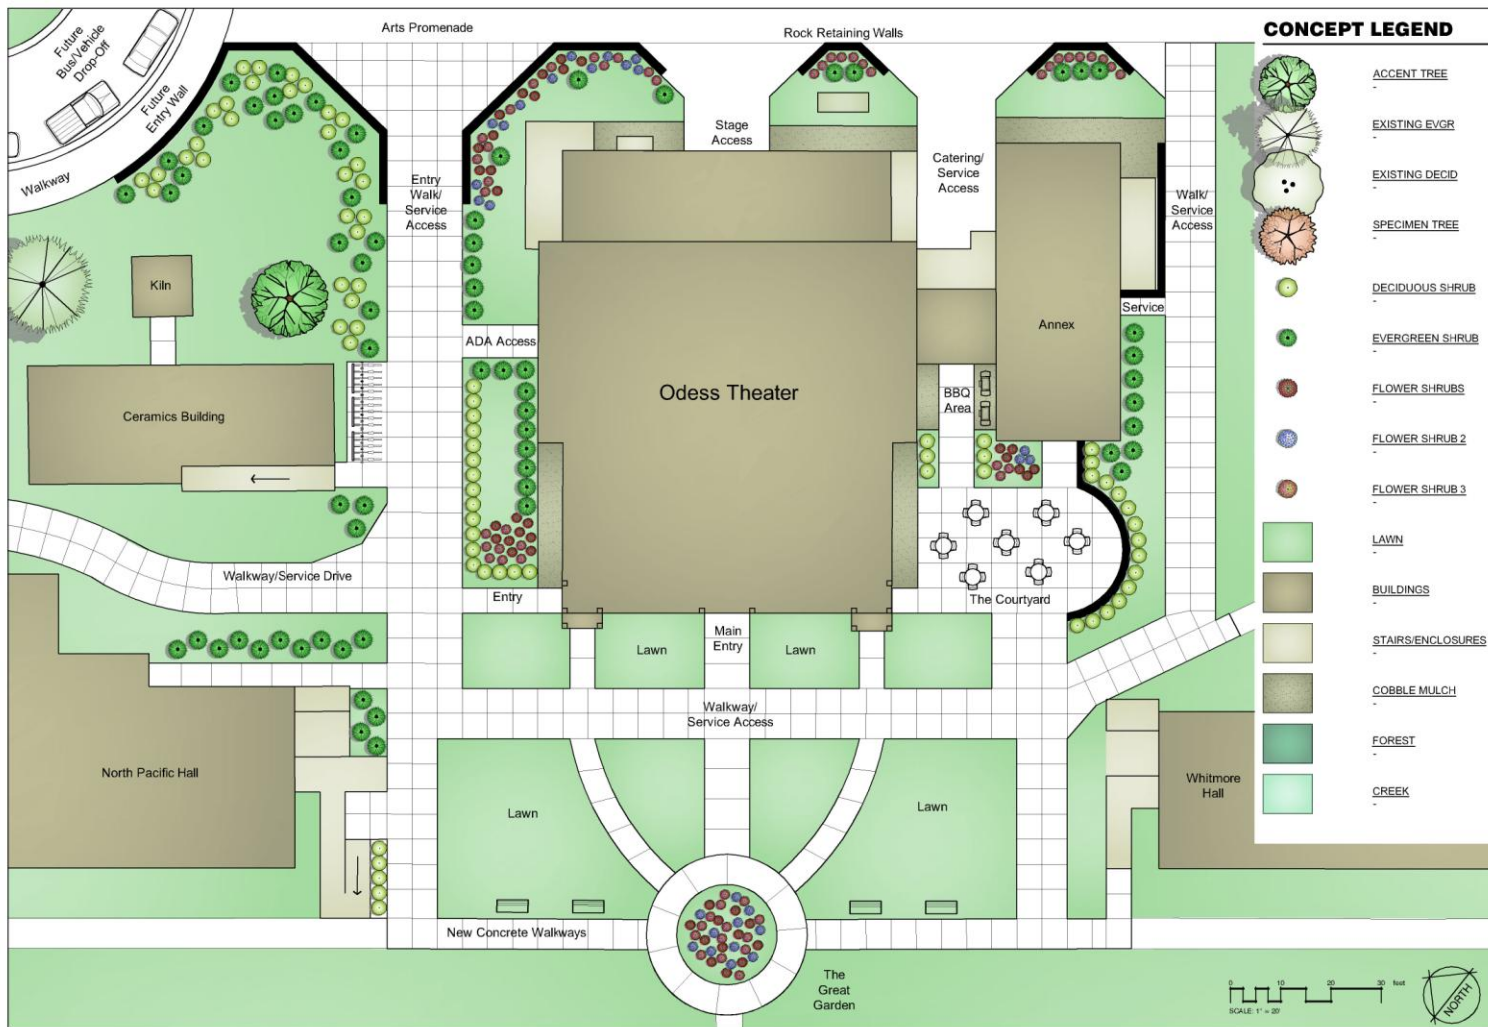
PROJECT:
Sitka Fine Arts Camp at Sheldon Jackson College
Odess Theater Walkways Concept
DATE: 1/4/16

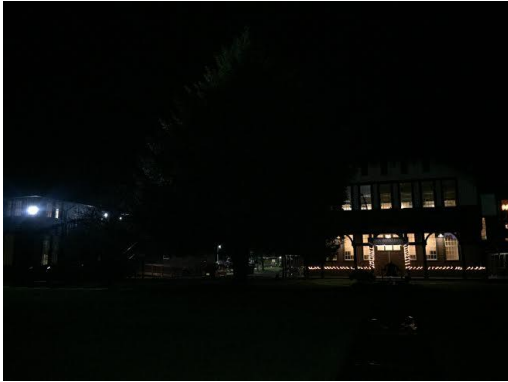
Lighting

Nighttime safe access to the building site is a priority.

There is also opportunity for accent lighting on the building.

Designer: Anderson Shirley Architects, Oregon
